## FRAMING STAGE INSPECTION - SAFE LIVING

1234 Main Street  
Adelaide, SA

18/09/2026 9:00AM

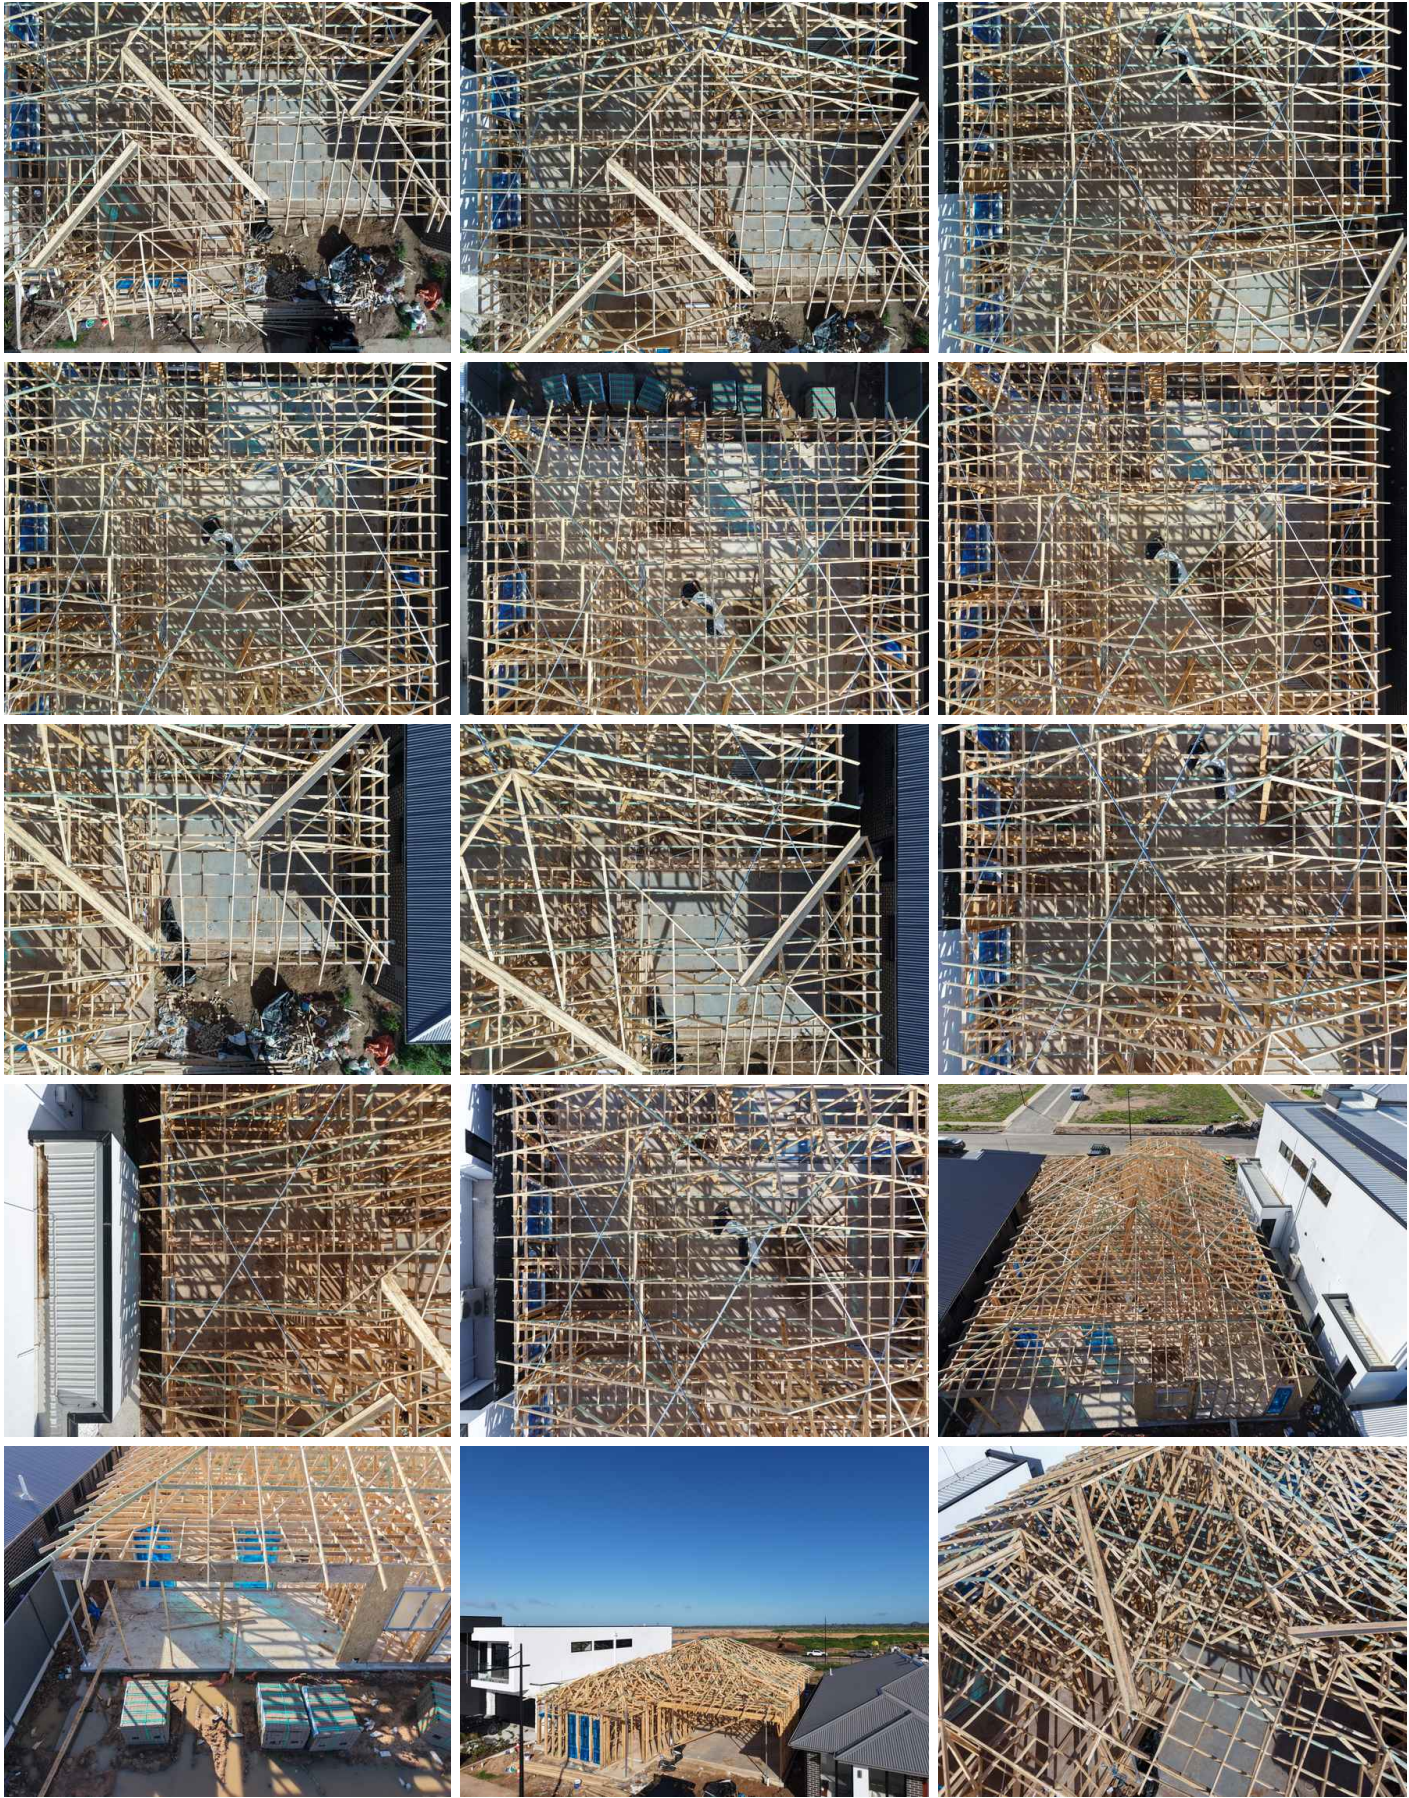
Truss Framing Layout

The truss layout was visually inspected from ground level and supplemented with drone imagery. The framing configuration was found to be acceptable and structurally sound based on observable conditions.

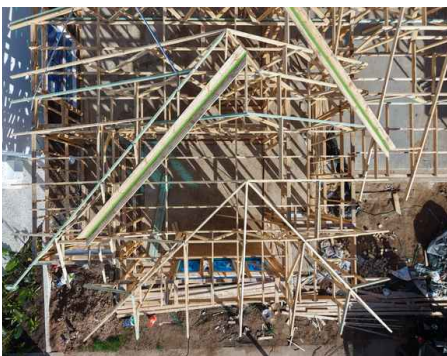
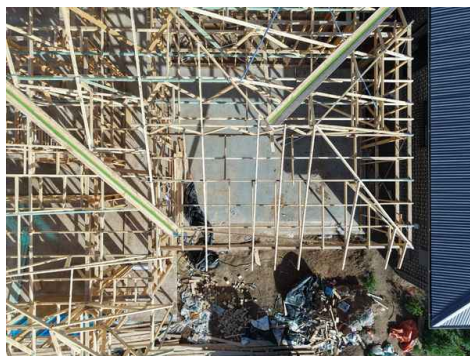
### Valley Boards: Valley Boards - Appear fine

Valley boards are structural components in roof framing that form the interior angles where two roof slopes meet. These boards provide structural support and serve as the base for roof covering materials in these critical areas.

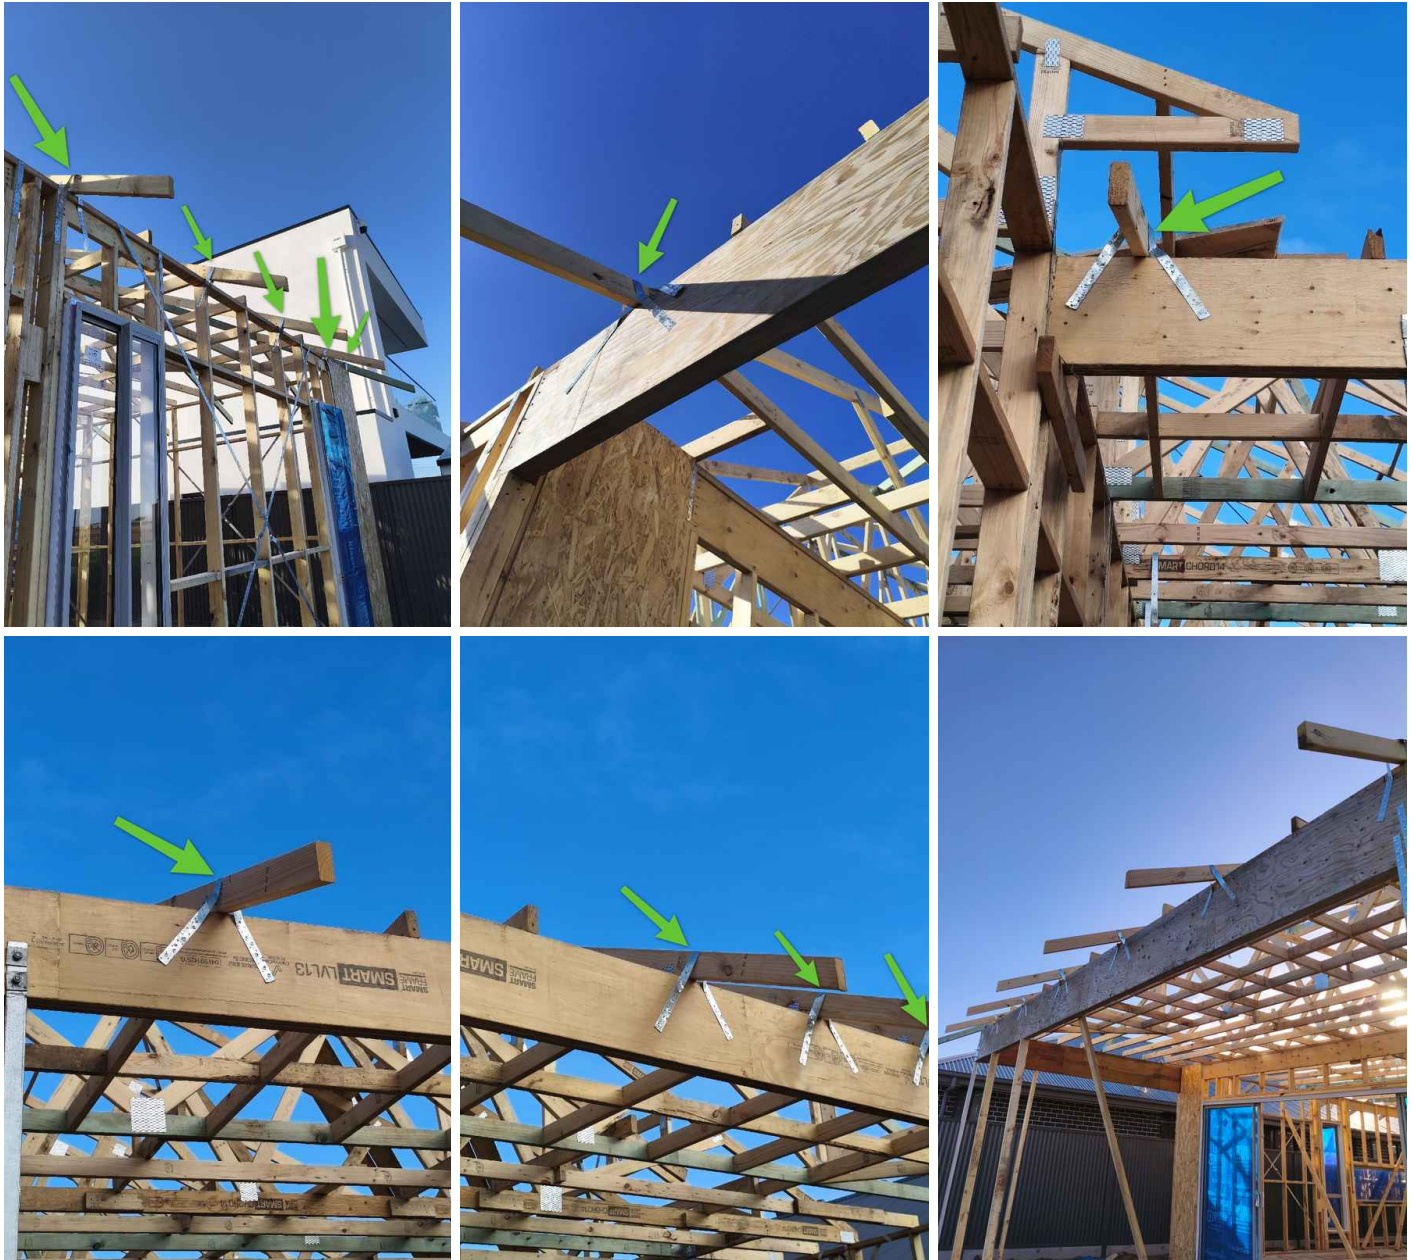
## Tie - Downs: Roof Tie-Downs - Acceptable

Roof tie-downs are structural connectors that secure the roof framing to the walls and foundation of a home. These connections help resist uplift forces from wind and other lateral stresses, providing structural integrity and stability to the overall building envelope. Properly installed tie-downs are an important component of a home's resistance to environmental forces.

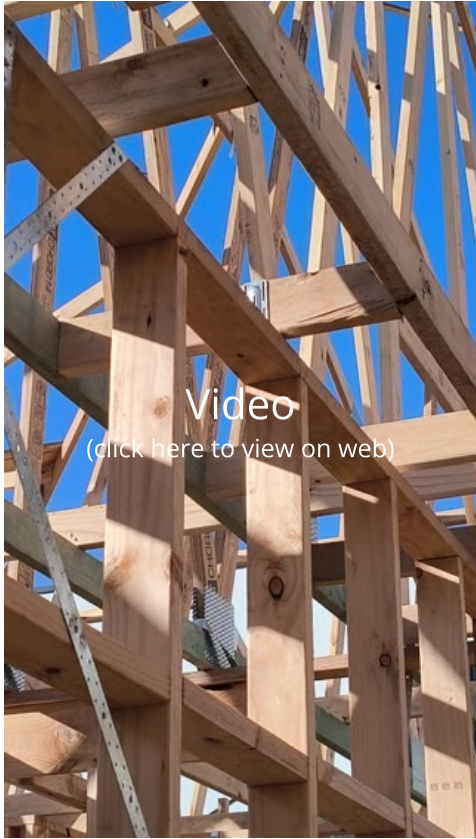
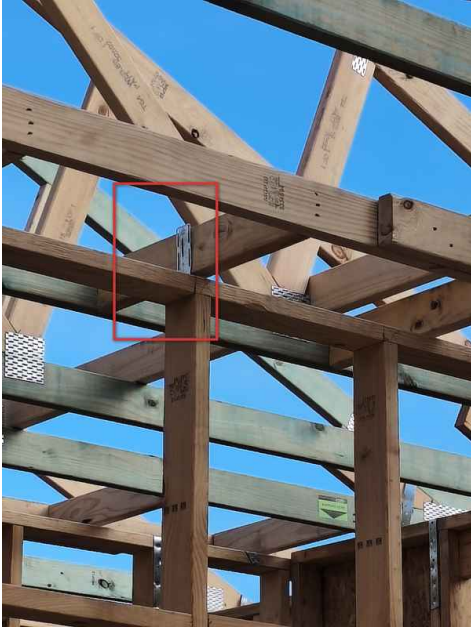
### 5.4.1 Triple Grips (Truss Tie)

#### **INCOMPLETE TRUSS AND TOP PLATE CONNECTION**

The connection between the truss and top plate is incomplete, meaning the structural fasteners or ties securing these critical components are not fully installed or engaged. This connection is essential for transferring roof loads to the walls and preventing lateral movement.

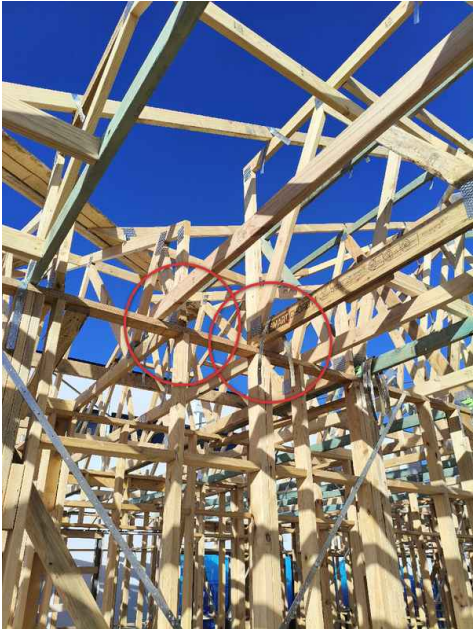
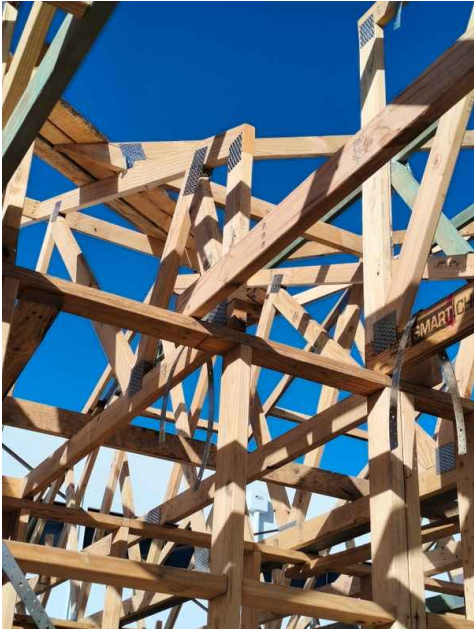
5.8.1 Tie - Downs

**INCOMPLETE TIE-DOWN CONNECTIONS**

The roof truss tie-downs to the top plate are incomplete. Roof trusses rely on secure connections to the top plate to resist uplift forces from wind and other lateral stresses.

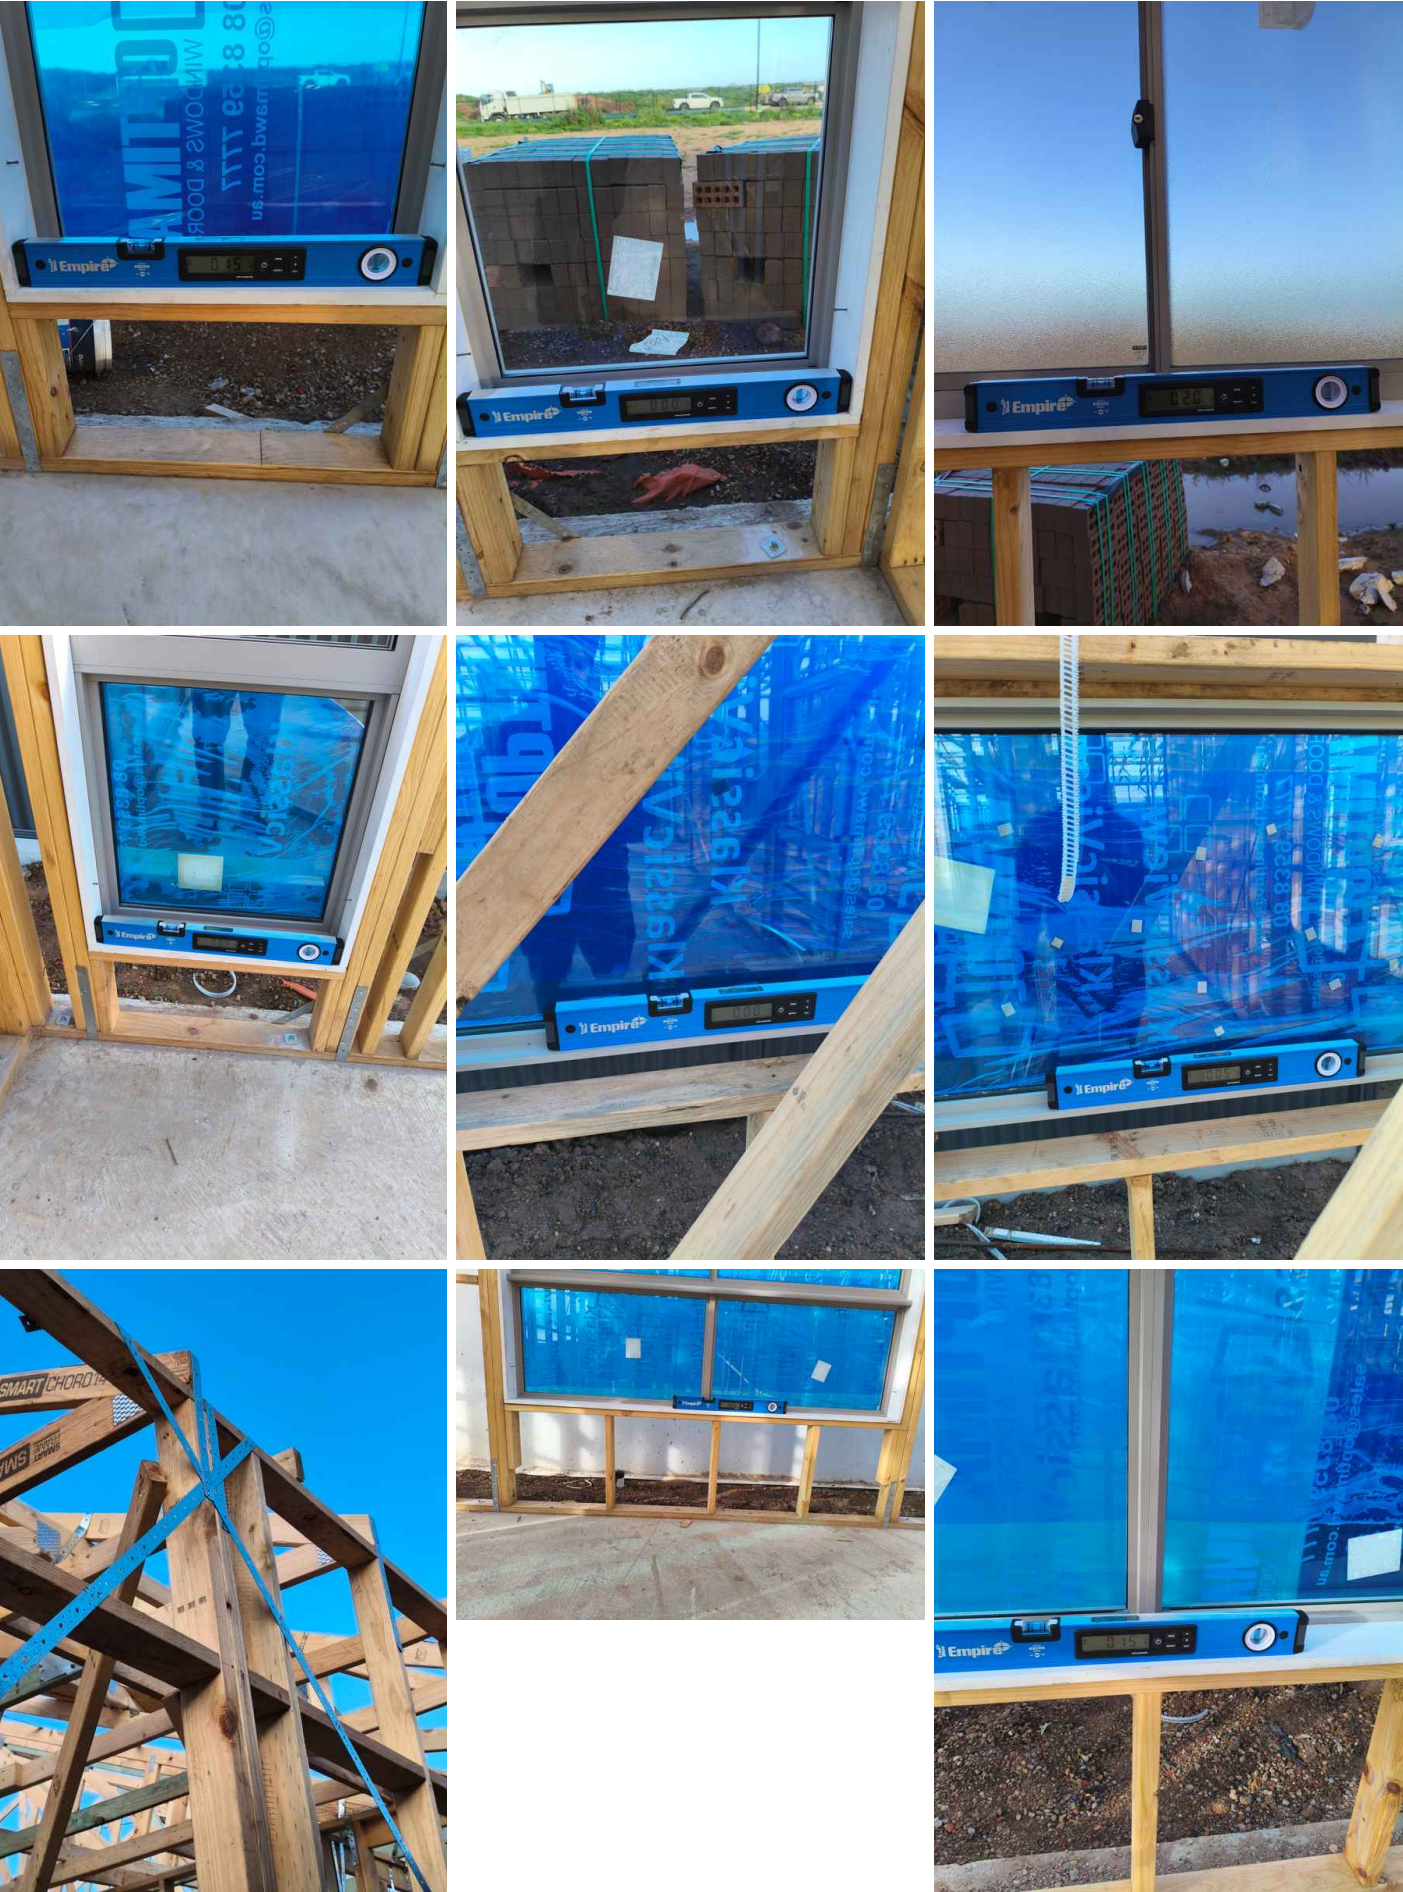
Windows: Window Framing Condition

Window framing was inspected and found to be within acceptable tolerance limits.

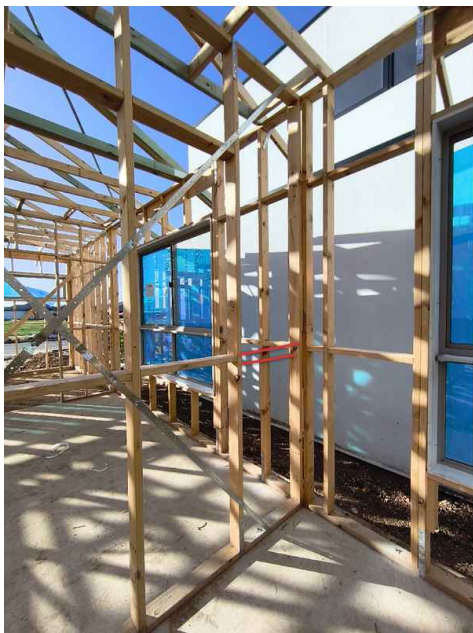
6.9.1 Noggings

MISSING NOGGING IN FRAME

A nogging section was not installed between frame members during framing.

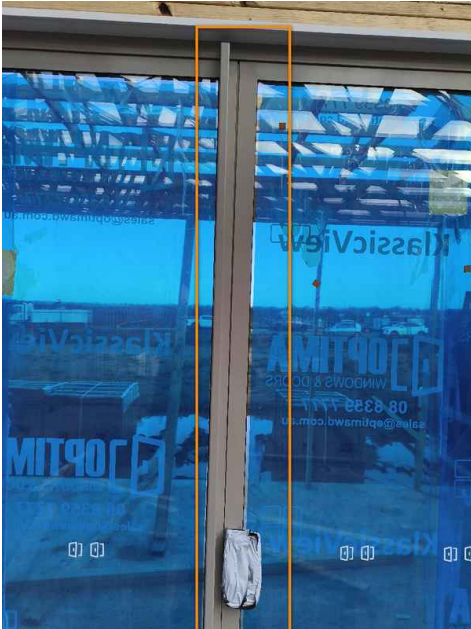
6.20.1 Slider Door

SLIDER DOOR  
ALIGNMENT

ALFRESCO

The slider door exhibits a minor gap when closing, indicating misalignment of the door frame or rollers. This was observed during the wall framing inspection.

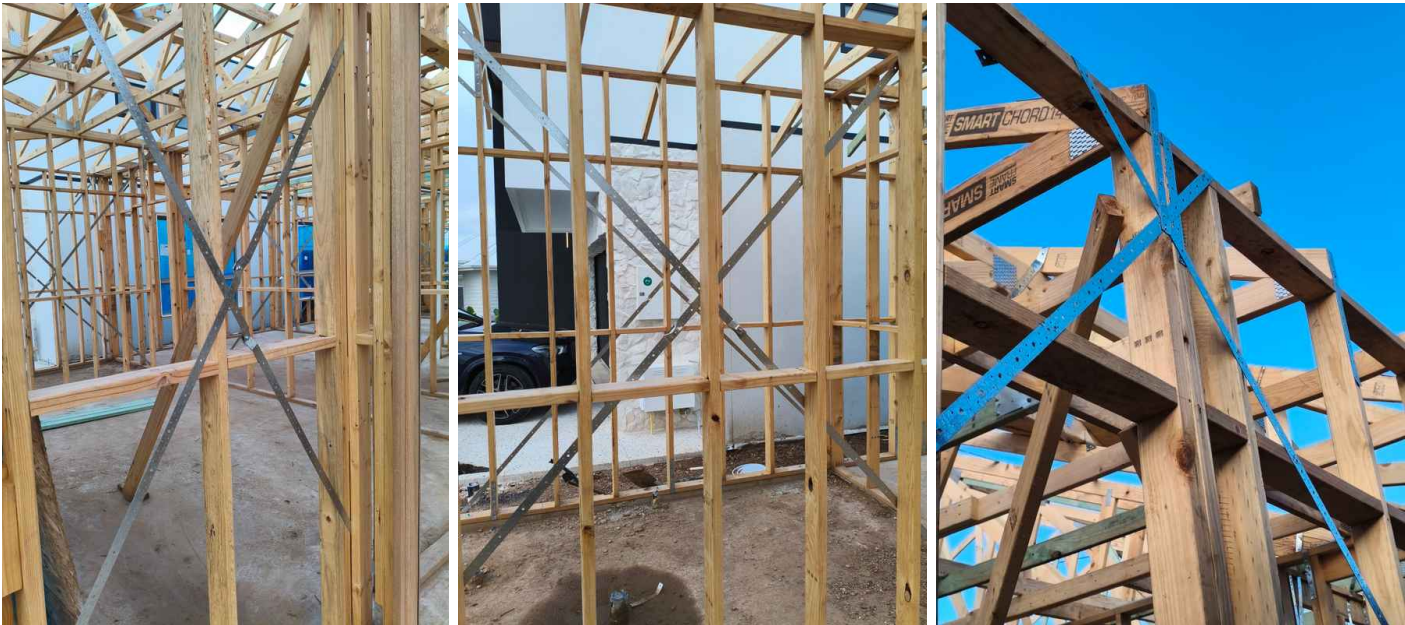
Metal Angle Brace/Strap: Metal Angle Brace/Strap - Acceptable

Metal angle braces and straps are structural reinforcement components used to provide additional lateral support and stability to wall framing.

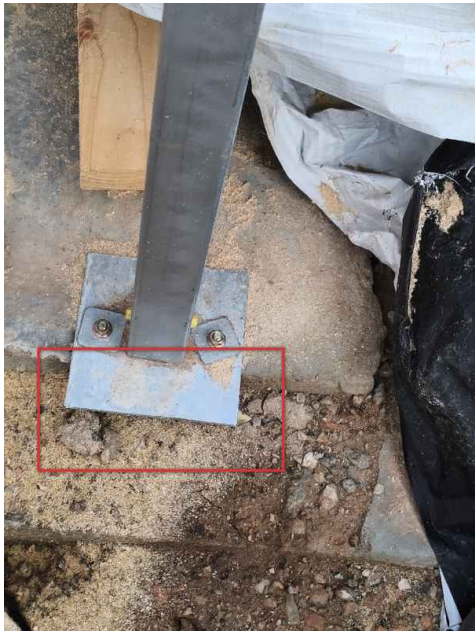
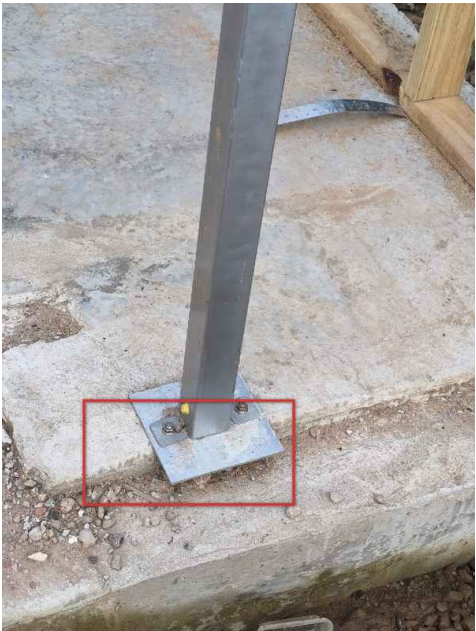
8.4.1 Structural posts

STRUCTURAL POST BASE PLATE SUPPORT

The base plate of structural posts requires proper support on the concrete slab. The area should be filled with structural load-bearing mix to ensure adequate bearing capacity and prevent settling or movement of the posts over time.

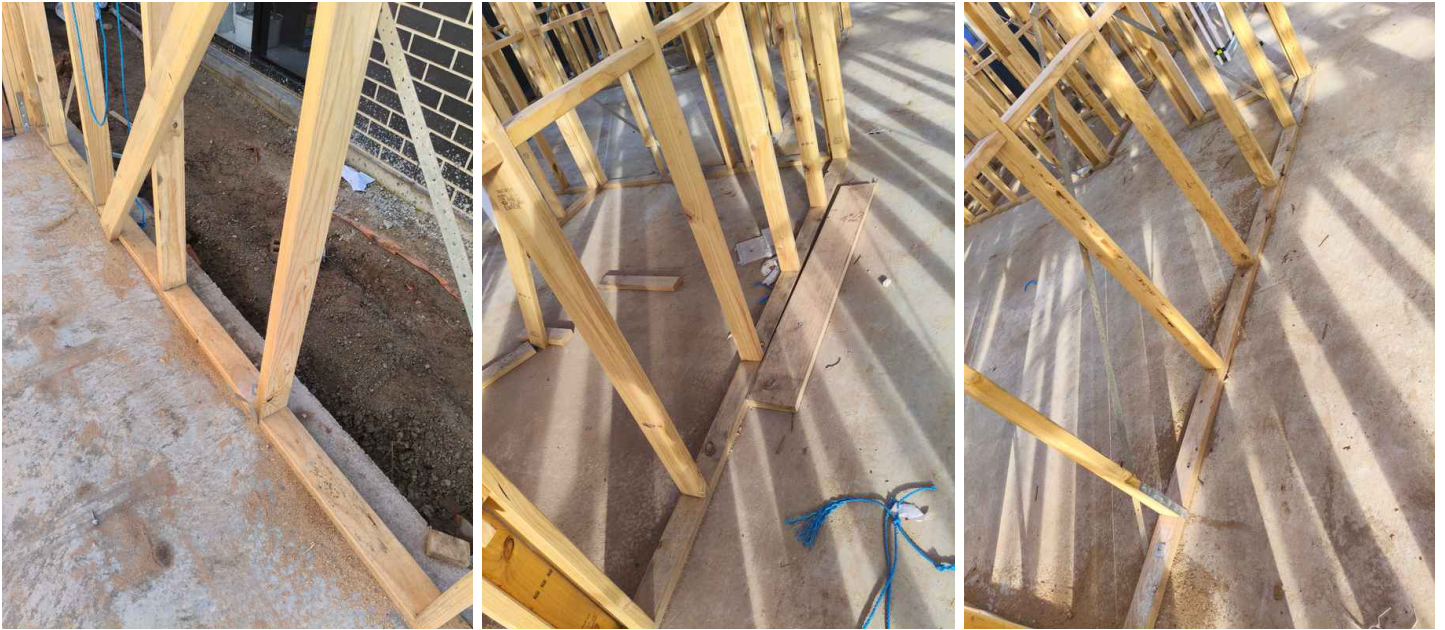
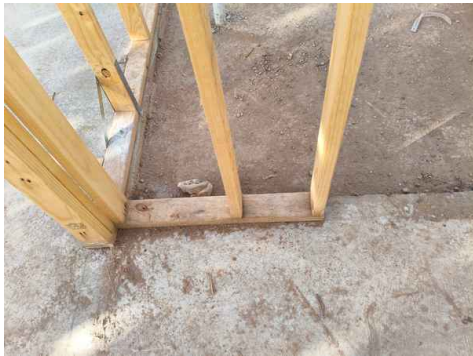
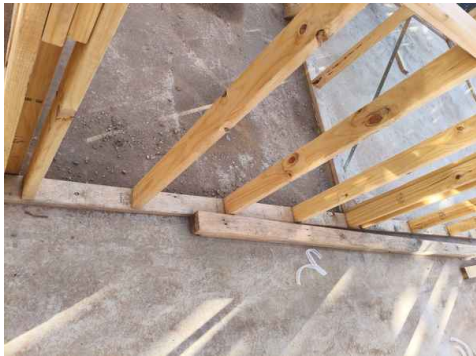
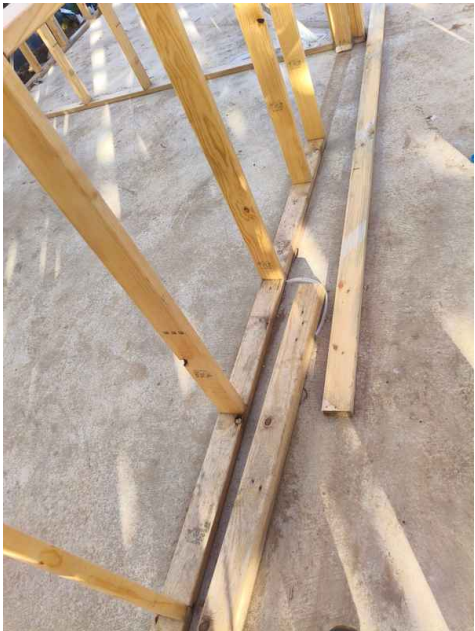
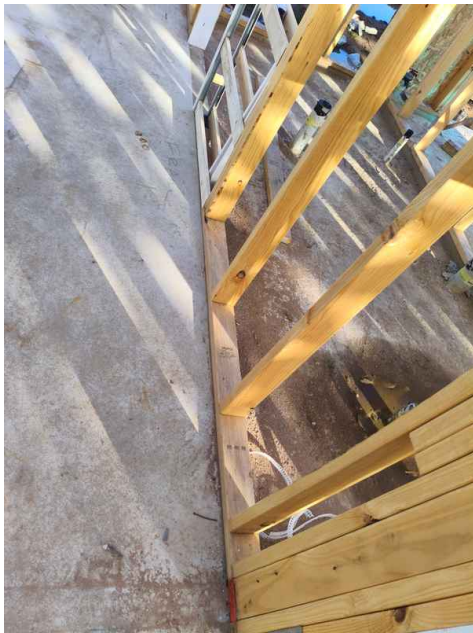
9.2.1 Bottom Plate to Floor Frame or Slab

**BOTTOM PLATE FIXING SPACING EXCEEDS STANDARD**

The bottom plate fastening to the concrete slab exceeds the recommended maximum spacing of 1200mm between fixings. [Table 9.4 - AS1684]

If using deadbolt fasteners - Maintain a minimum of 50mm from the edge
