SAFE LIVING INSPECTIONS

## POST-POUR INSPECTION- RESIDENTIAL -SAFE LIVING

1234 Main Street  
Adelaide, SA

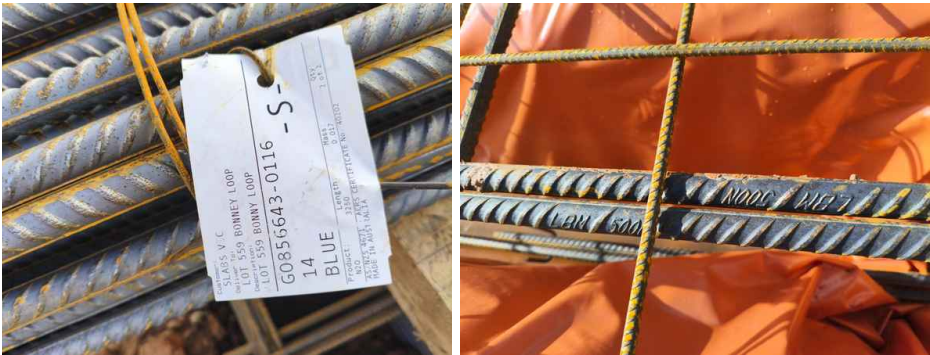
Steel Grade/size: Acceptable

The concrete slab is reinforced with N20 grade steel at 500 newton specifications, installed according to the footing plan. This reinforcement provides structural support and helps distribute loads throughout the slab system. [AS 2870 ]

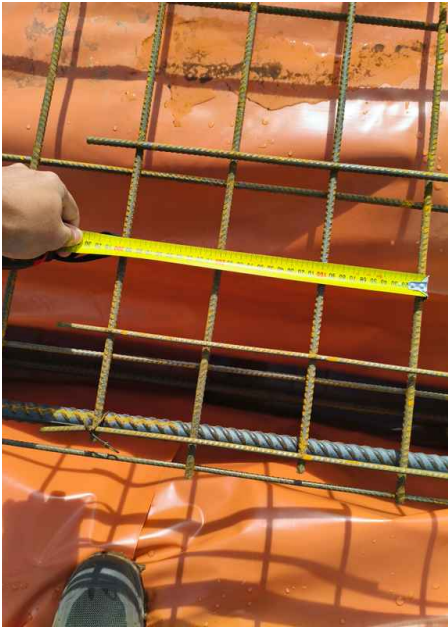
### Mesh Overlap: Acceptable

Reinforcing mesh overlap in the slab foundation was observed during inspection. The overlap measured a minimum of 250mm, which satisfies NCC Part 3.2.3 requirements for proper reinforcement continuity and structural integrity.

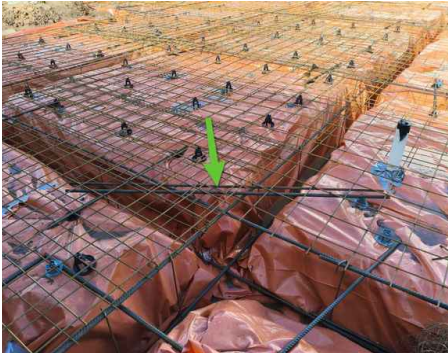
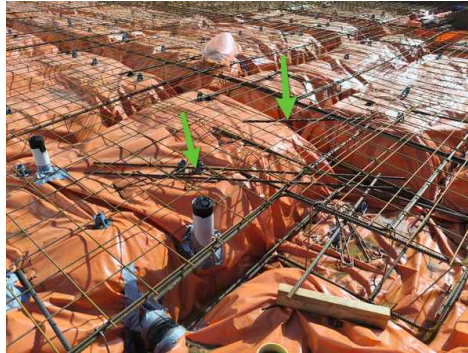
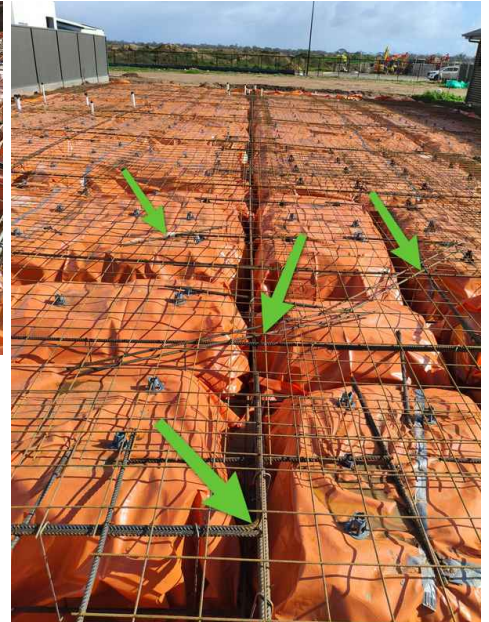
### Corner/ Diagonal Reinforcement: Acceptable

Corner reinforcements in the slab foundation were inspected and found to be satisfactory according to the footing plan specifications. This indicates proper structural support at the slab corners where stress concentrations typically occur.

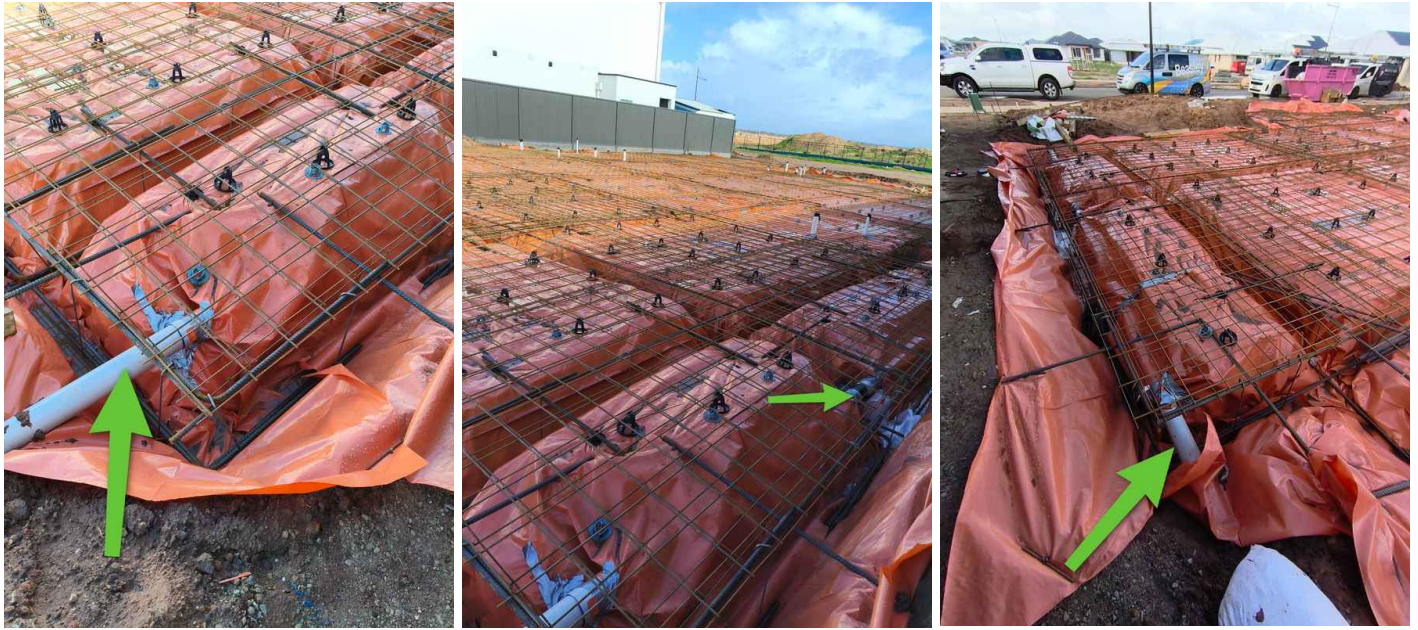
**Openings/sleeves : Acceptable**

Openings and sleeves in the slab were found to be satisfactory and acceptable according to the footing plan. Plumbing openings were verified against the plans, including a storm water sleeve positioned under the garage. Final dimensions will be clarified after the concrete pour is completed.

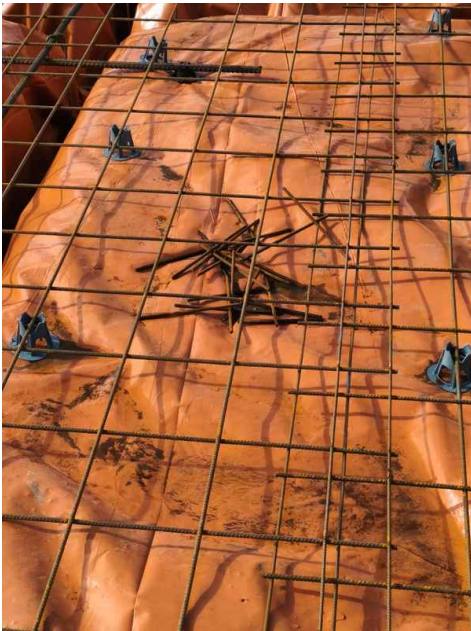
#### DEBRIS IN CONCRETE POUR AREA

Cut scrap steel pieces were observed within the concrete formwork prior to the pour. Leaving loose debris in the concrete can create air pockets and reduce the compressive strength of the finished concrete. The debris should be completely removed before the concrete pour begins to ensure proper structural integrity.

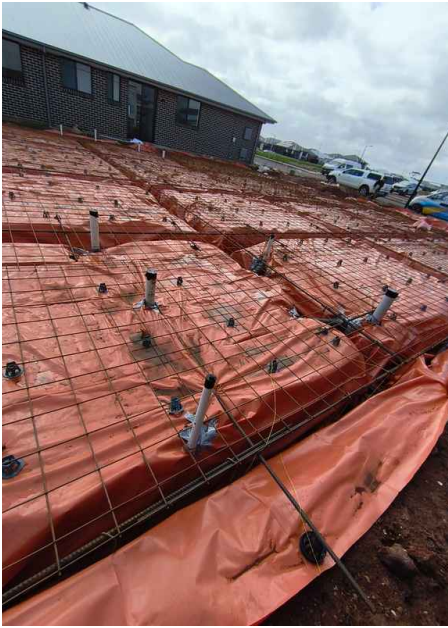
**Vapour Barrier: Vapor Barrier Condition**

The vapor barrier beneath the slab was found to be in acceptable condition during the pre-pour inspection. A vapor barrier is a protective layer installed under concrete slabs to prevent moisture from rising through the slab, which helps protect flooring materials and the interior environment from moisture-related damage.

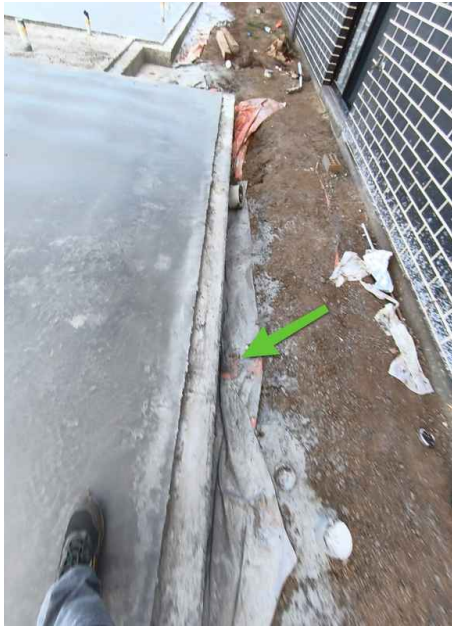
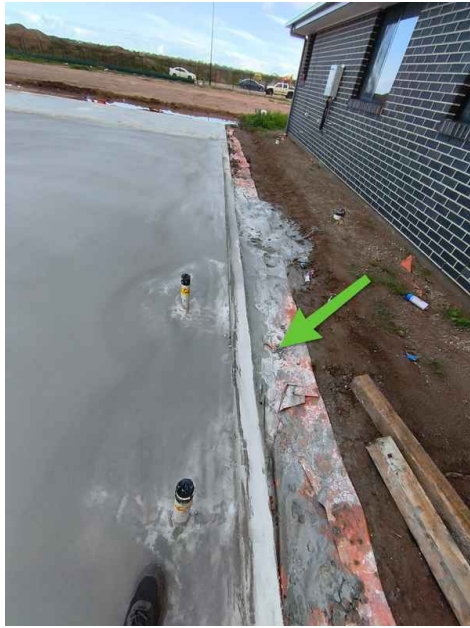
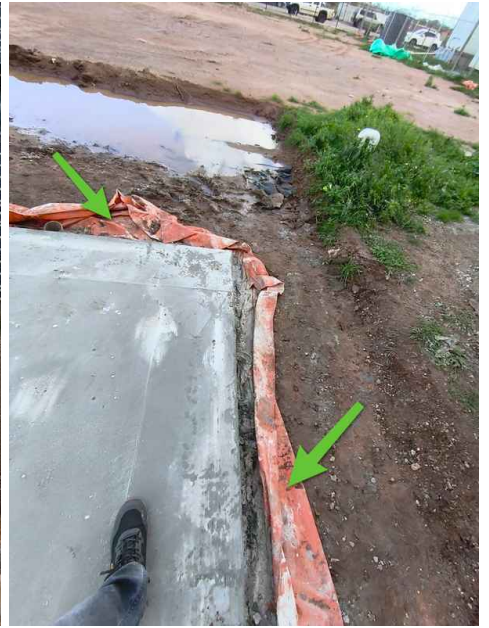
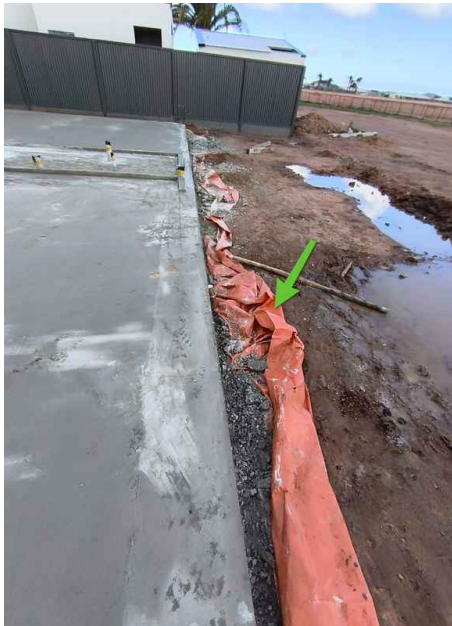
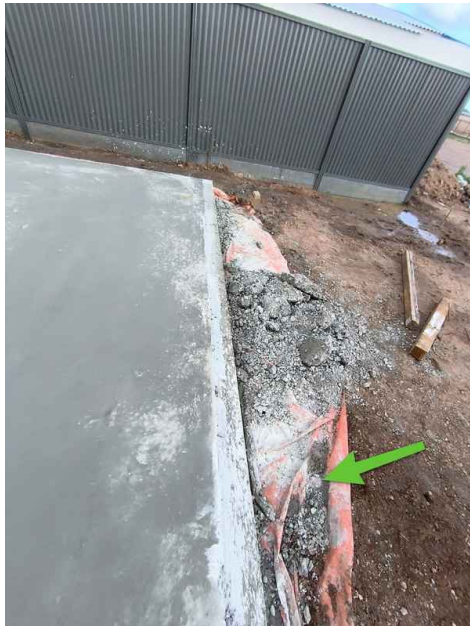
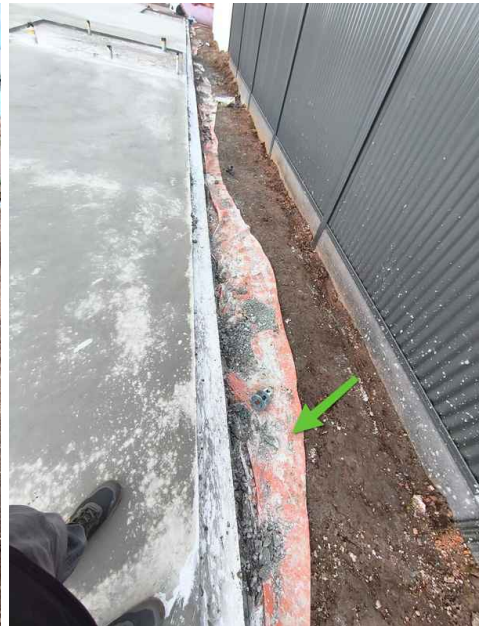
**Vapour Barrier: Vapor Barrier Visible After Slab Pour**

A vapor barrier was observed visible after the concrete slab pour, which indicates proper installation beneath the slab. Soil baking should be completed after the concrete has fully set and site grading work is finished to ensure proper moisture management and ground preparation.

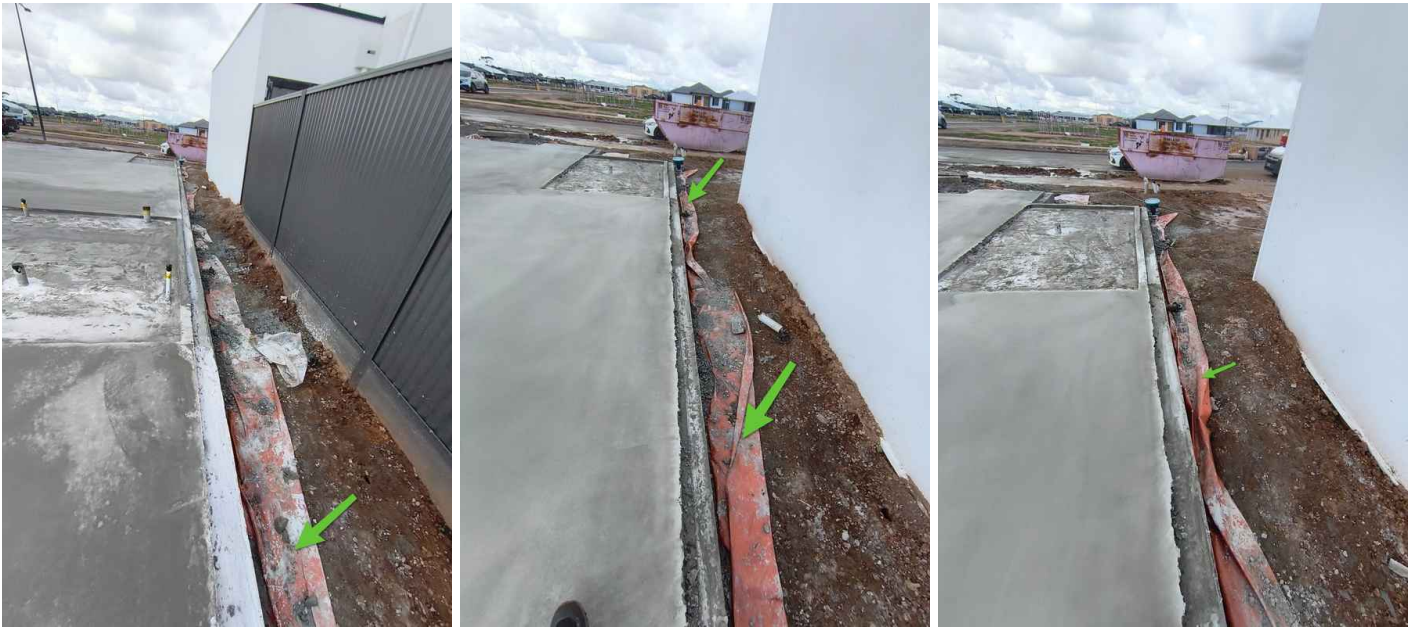
Site grading: Site Grading Management

Site grading refers to the contouring and leveling of soil around the foundation to direct water drainage away from the structure. Proper grading is essential during construction to ensure adequate slope, prevent water pooling near the foundation, and protect the damp-proof course (DPC) and soil backing. According to the stamped plans, site grading requires ongoing attention and management throughout the construction process, with particular focus on protecting the DPC installation and maintaining proper soil support behind it.

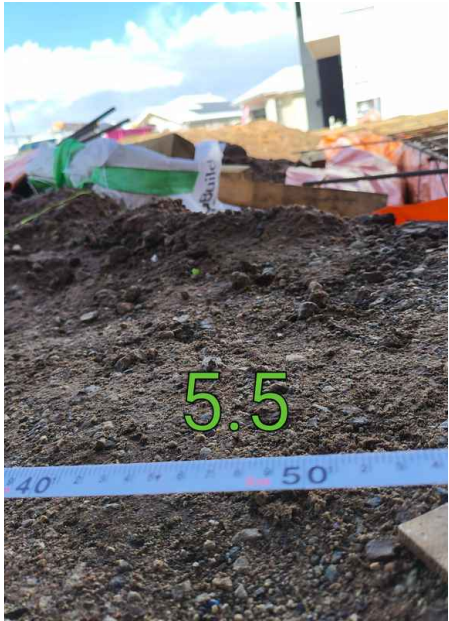
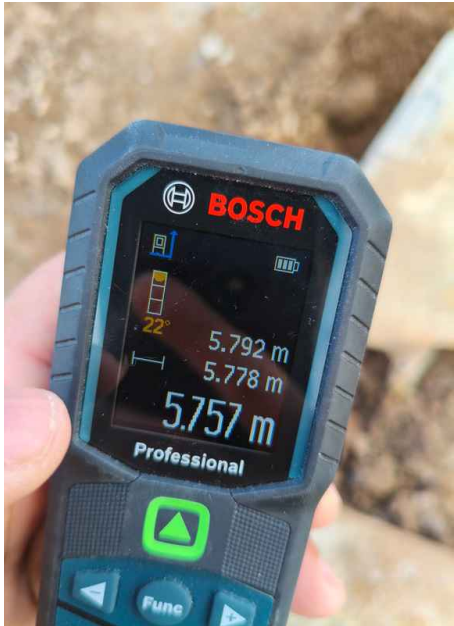
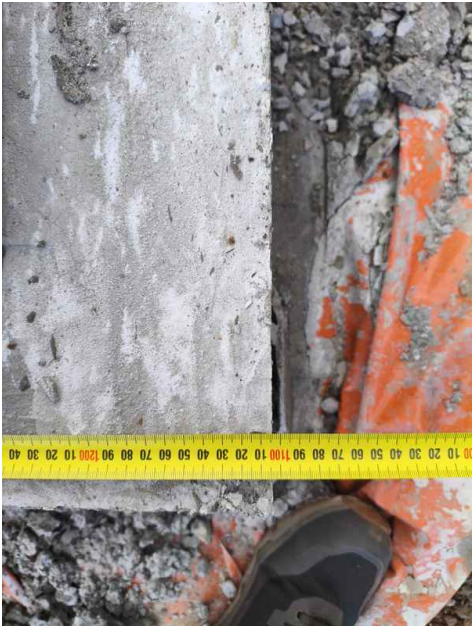
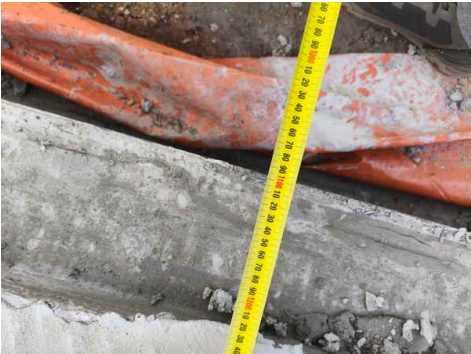
Off Set : Slab Offset - Acceptable

The concrete slab offset was measured and found to be acceptable relative to neighboring buildings. The offset dimensions were verified both at the front and rear of the property following the concrete pour.

| Garage offset | 5500mm + 250 [approx - for services ] |
| Rear Offset | 4100mm |
| Behind garage - zero point offset | 1000mm |
| Neighbor parameter offset | 1100mm |

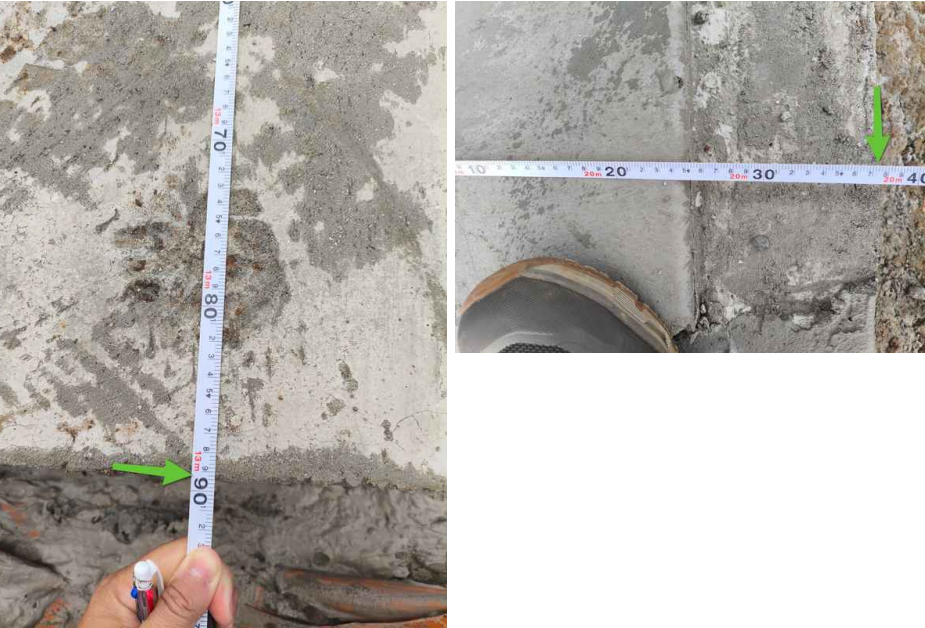
**Slab dimensions : Slab Dimensions**

The external slab dimensions were measured and verified against the construction plans. The long edges of the slab were found to be within acceptable tolerances as specified.

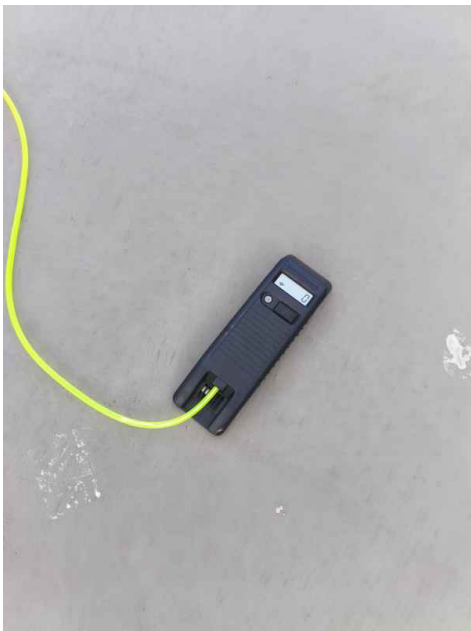
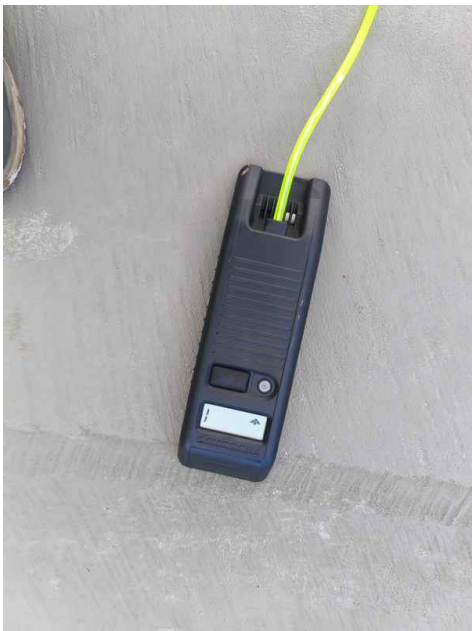
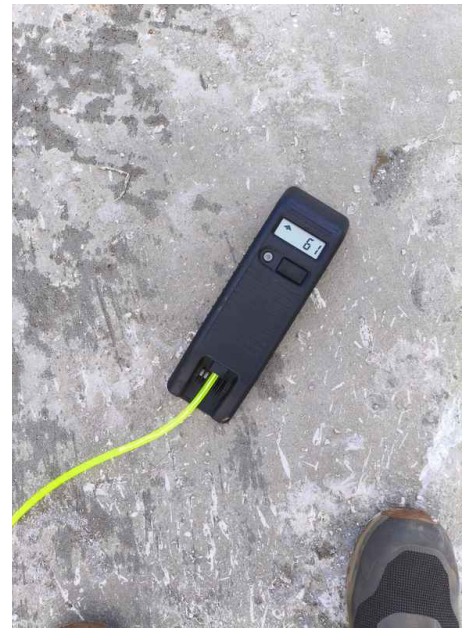
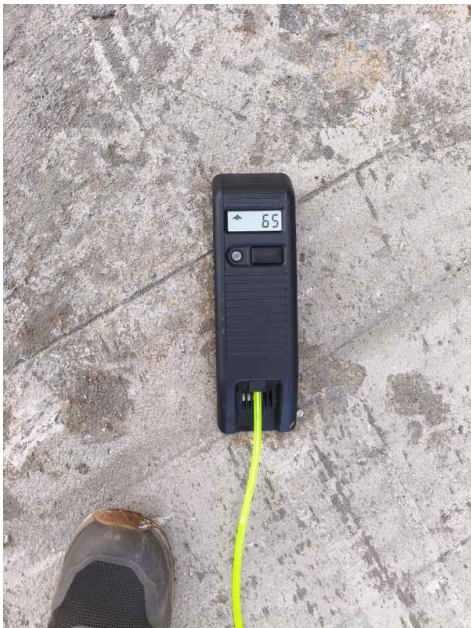
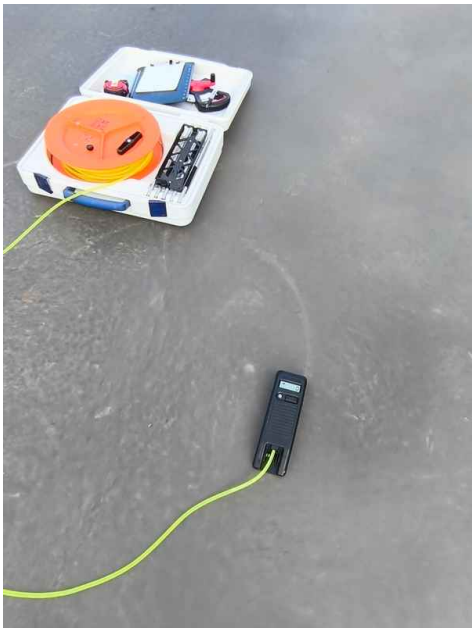
Slab levels as per Nivcomp: Slab Levels Within Tolerance

Slab levels were measured using a digital level (Nivcomp) and found to be within acceptable tolerance limits. This indicates the concrete foundation slab is properly graded and settled appropriately, with no significant deviations that would suggest structural concerns or drainage issues.
